Orange Lake Summary of Field Activities

Orange Lake Improvement Board
Bloomfield Township, Michigan

Environmental Consulting & Technology, Inc.

July 2003

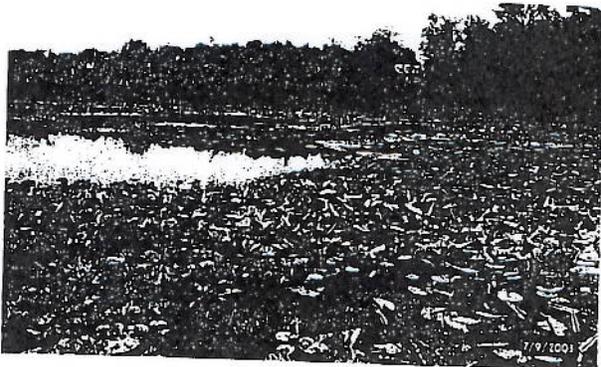
Unconsolidated sediment has accumulated in Orange Lakes at thicknesses exceeding 10 feet. The lake bottom sediment thickness appears to be the shallowest along the northeast and southwest shorelines. Sediment accumulation appears the greatest in the northeast section of the lake and along the north and south shores of the lake. However, the majority of the lake

consistently had 6 feet or greater of sediment accumulation, of which some is historic. As indicated in the Bathymetry Section of this summary, the lake has been reduced in size from the 1947, 40 acres to approximately 33 acres today. This could be do impart to sediment accumulation (other factors could be filling in of pasture or marshlands during development) reducing the surface area. Additionally, a comparison of the two maps shows that will there has been some reduction in water depths in the western end of the lake, the eastern end of the lake has had the greatest decrease in water depth and therefore increase in the sediment thickness.

The lake bottom material along southwest shoreline consists of sand with some gravel. The northeast shoreline consists of a brown sandy muck that is underlain by a black sandy muck. The unconsolidated sediment in the lake often contained undecayed organic debris such as wood. A contour map illustrating sediment thickness is included in Figure 4. Cross-Section of the lake based on the water and sediment thickness are shown in Figures 5A, 5B, 5C, and 5D.
